# TREATMENT OF ACID MINE DRAINAGE USING FISHBONE APATITE II<sup>TM</sup><sub>1</sub>

Neal A. Yancey<sub>2</sub> and Debby Bruhn<sub>3</sub>

**ABSTRACT.** In 2000, a reactive barrier was installed on the East Fork of Ninemile Creek near Wallace, Idaho to treat acid mine discharge. The barrier was filled with fishbone derived Apatite II<sup>TM</sup><sub>4</sub> to remove the contaminants of concern (Zn, Pb, and Cd) and raise the pH of the acidic mine discharge. Metal removal has been achieved by a combination of chemical, biological, and physical precipitation. Flow for the water ranges from 5 to 35 gallons per minute. The water is successfully being treated, but the system experienced varying degrees of plugging. In 2002, gravel was mixed with the Apatite II<sup>TM</sup> to help control plugging. In 2003 the Idaho National Laboratory was ask to provide technical support to the Coeur d'Alene Basin Commission to help identify a remedy to the plugging issue. Air sparging was employed to treat the plugging issues. Plastic packing rings were added in the fall of 2005, which have increased the void space in the media and increased flows during the 10 months of operation since the improv

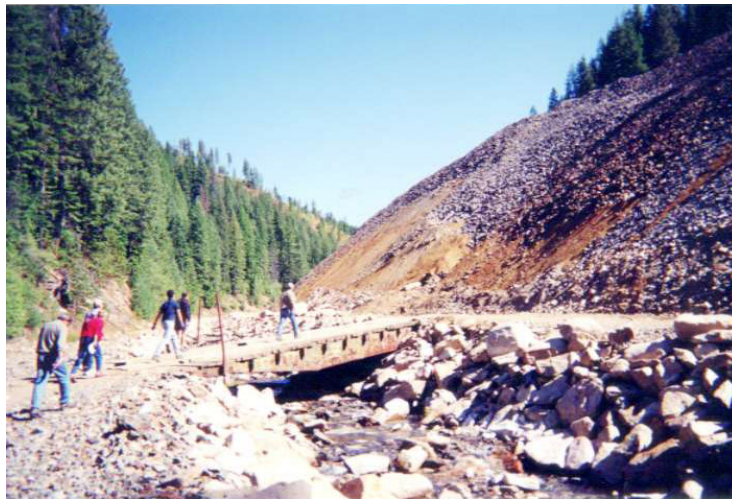
Figure 1.0 Ground and Surface Water Passing through Mine Tailings

Groundwater flows from the adjacent hillsides and comes up in various locations in the canyon floor. Portions of this water comes up through the tailings pile and flows down gradient until it enters the creek, again carrying with it increased levels of dissolved and suspended metals with a lowered pH level.

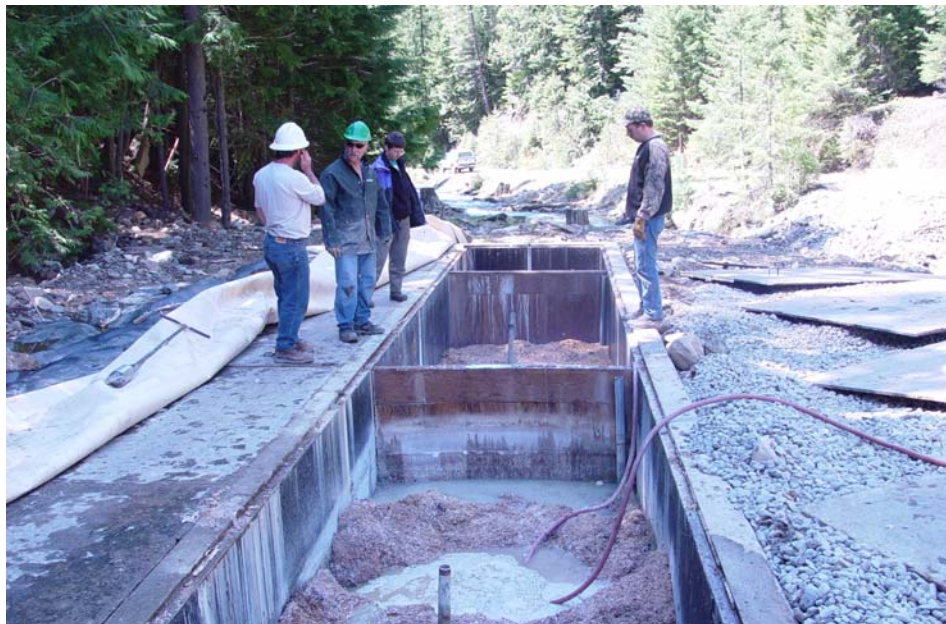
In 2000, a 45 foot long 12 foot deep reactive barrier was constructed to treat acid mine drainage resulting from surface and groundwater passing through mine and mill tailings at the Success Mine on the East fork of Ninemile Creek near Wallace, Idaho. The reactive barrier was constructed having two separate sides, each 6 foot wide, 12 feet deep, and 45 feet long (See Figure 2). On each side of the reactive barrier, water flows over and under alternating baffles to

create as much contact between the media and contaminated water as possible. Each side of the reactive barrier has 5 cells separated by these alternating baffles (Figure 2).

Figure 2.0. Construction of the Reactive Barriers at the Success Mine Site.

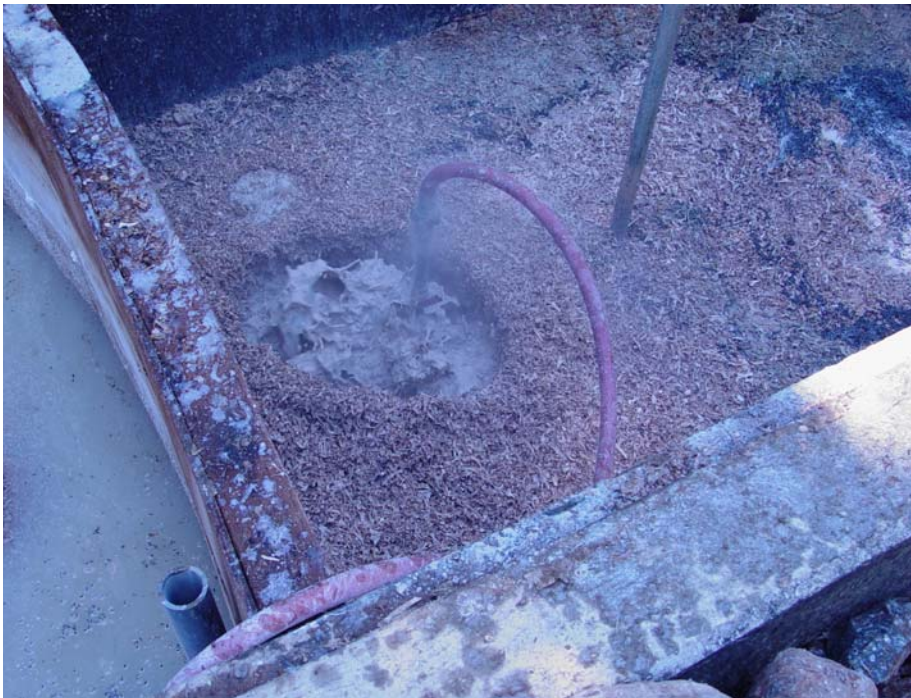
The covers to the reactive barriers were removed to provide access to the media. A 10 foot galvanized hollow wand was fabricated to inject compressed air deep into the media. Compressed air was injected in at least two locations in each of the 5 cells for both the East and West side of the reactive barrier (See Figure 3).

Figure 3. Injecting Compressed Air in the Apatite II<sup>TM</sup> Media.

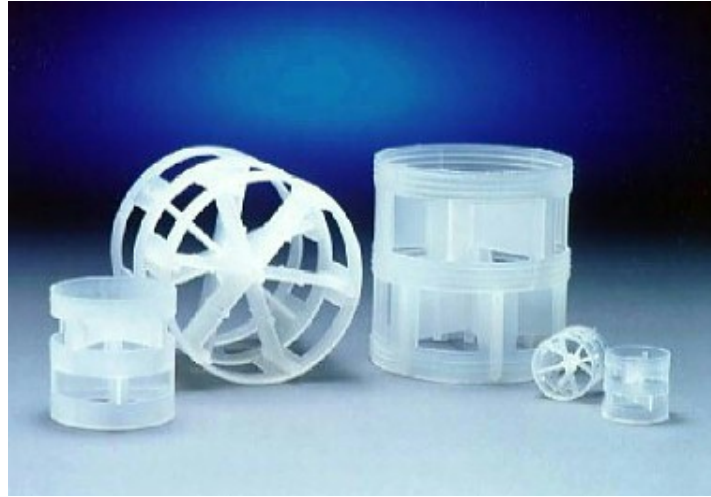
surface area for microbial attachment and increase the reactive area of the media. They are also used to increase the void space in the media (Figure 4).

Figure 4. Plastic Packing Rings.

In November of 2005, the media in the East side of the reactive barrier was replaced with new Apatite II<sup>TM</sup> mixed with plastic packing rings at a ratio of 30 volume % plastic packing rings. Two inch Jaeger plastic packing rings were used to provide an increase in void volume in the reactive barrier. The increase in void volume was desired to provide more area for water to flow through in the Apatite II<sup>TM</sup> media and to provide more volume for sediments and precipitates to form without impacting the flow. Figure 4 is a picture of the packing rings used in the reactive barrier. By themselves, the plastic rings have a void volume of 92%. Information on the void space of Apatite II<sup>TM</sup> was not available, but had noticeably less void volume than the plastic rings alone.

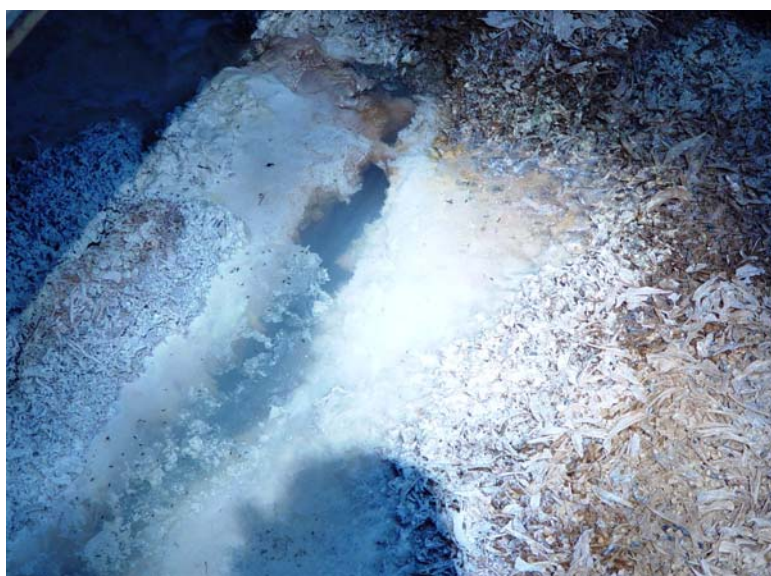
The reactive barrier was constructed in 2000 and the first Apatite II<sup>TM</sup> was placed in the barrier in January of 2001. Other than adding new media to the East side of the reactive barrier in 2002, nothing had been done to deal with the plugging issues associated with the reactive barrier. The cause of the plugging was a combination of sediment buildup from the influent stream and sedimentation occurring from the breakdown of the Apatite II<sup>TM</sup>. Figure 9 illustrates the sediment buildup that had occurred in the West side of the reactive barrier. Note the buildup of sediment in the Apatite II<sup>TM</sup> and notice how the water has formed preferential paths in the media resulting in inefficient contact of water and the reactive media.

Figure 9. Sediment buildup in the Reactive Media.

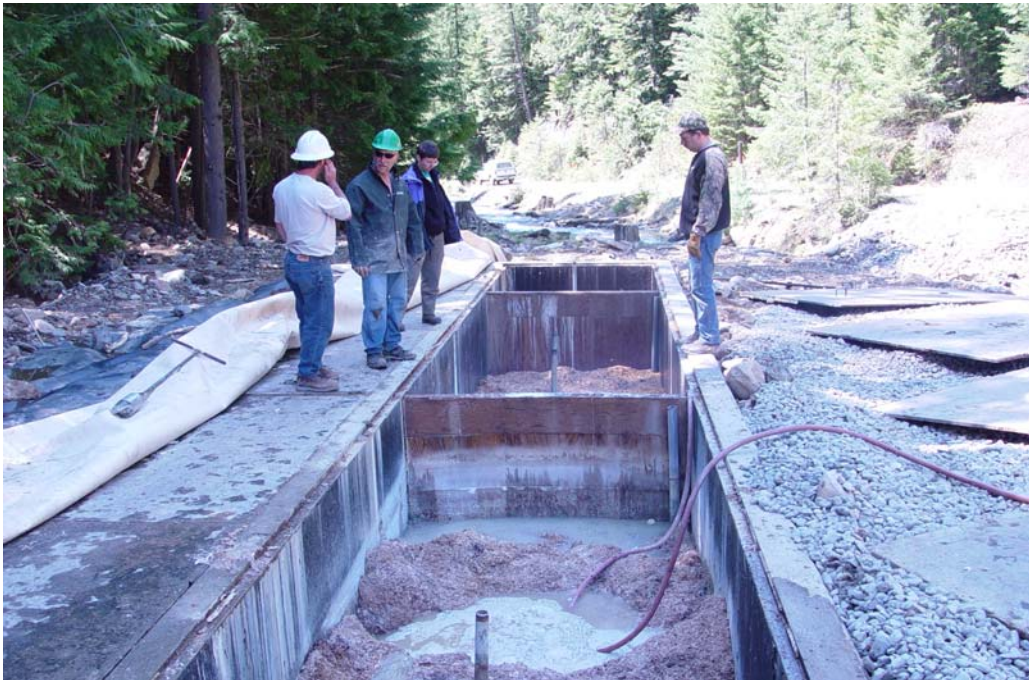
Another similar site in the Coeur d'Alene basin is using Apatite II<sup>TM</sup> to treat acid mine drainage at the Nevada Stewart Mine. At this location, compressed air is injected into the media combat the effects of plugging on the reactive barrier. This results in temporarily increased flow in the media at the Nevada Stewart Mine site. For the reactive barrier at Success, a ten-foot hollow wand was constructed to inject air deep into the media at the Success Mine reactive barrier. Figure 10 shows the workers injecting air into the media at the Success Mine.

Figure 10. Injection of Compressed Air into the Reactive Media.

The result of the injection of compressed air into the media was an immediate increase in flow through the reactive barrier, primarily on the West side. The presence of the gravel on the East side made it difficult to get the metal wand into the media to successfully inject the air into the media. This resulted in only limited success on the East side of the reactive barrier.
